# Development of Autonomous Enforcement Approach using Advanced Weigh-In-Motion (A-WIM) System to Minimize Impact of Overweight Trucks on Infrastructure

USDOT Award No. 69A3551747124

September 2021

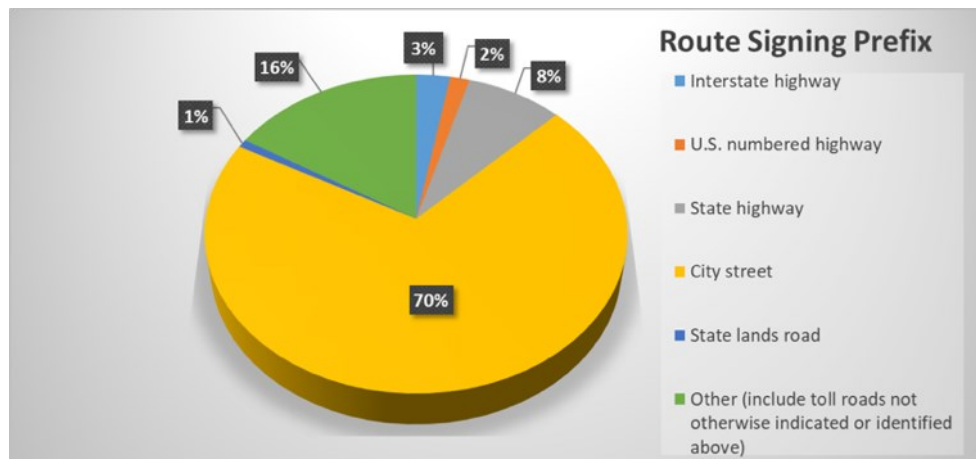
**Figure 1: Distribution of Route Signing Prefix in Bridge Inventory**

Route Signing Prefix identifies the route signing prefix for the inventory route. It includes the Interstate highway, U.S. numbered highway, state highway, county highway, city street, federal lands road, state lands road, and others. The distribution is shown in Figure 1.

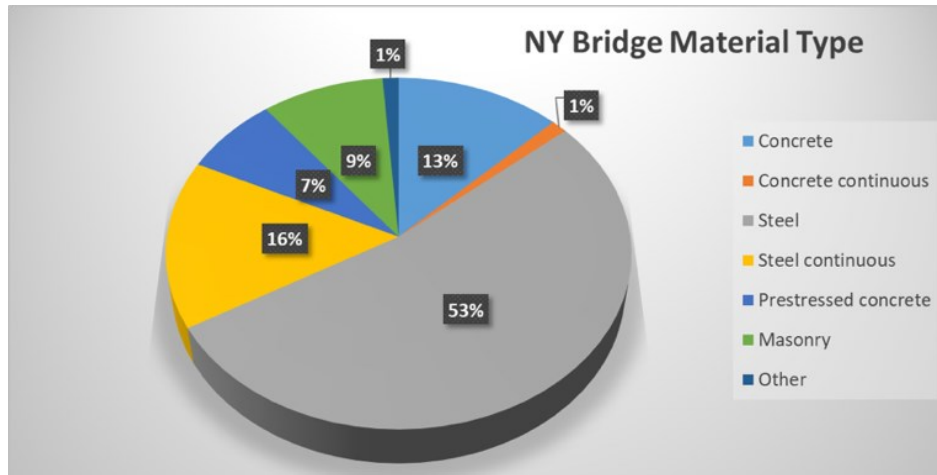
**Figure 2: Distribution of Bridge Material Type in Bridge Inventory**

In the NBI database, item 43A classifies the bridge by the material of the superstructure. The material includes concrete, concrete continuous, steel, steel continuous, prestressed concrete, masonry, etc. The distribution is shown in Figure 2. Therefore, the figure shows that the most predominant type of bridge is simply supported steel bridge. More than half of the bridges in New York County are simply supported steel bridges. And the second is the steel continuous bridge.

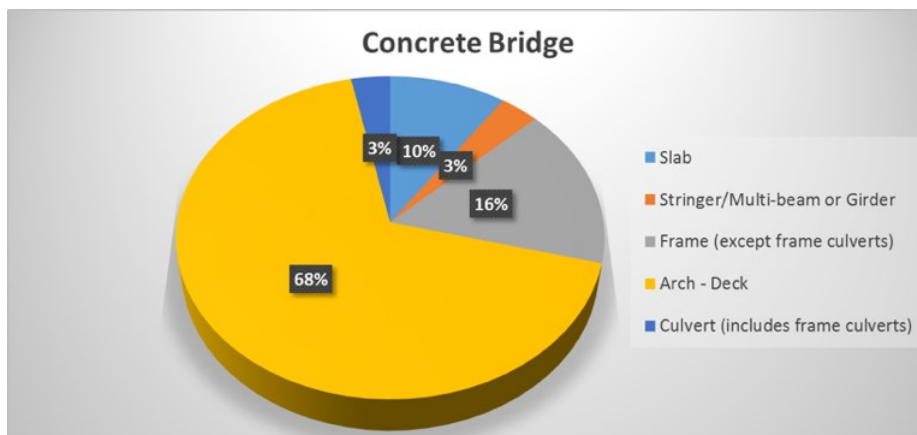
**Figure 3: Distribution of Structural Types in Simply Supported Concrete Bridges**

Item 43B describes the type of design (structure type) of the bridge. The distribution of each material type was drawn to identify the portion of each structure type in the same material category. Figure 3 to Figure 7 show the structure type distribution in each material type. For the concrete bridge, the culvert structure type (68%) takes the most portion in all types of structure. For steel bridge, girder and floor beam system has the highest percentage of 85, while for steel continuous, most are Stringer/Multi-beam or Girder. For the prestressed bridge, half of the bridges are Stringer/Multi-beam or Girder. And for masonry, all of them are Arch – Deck.

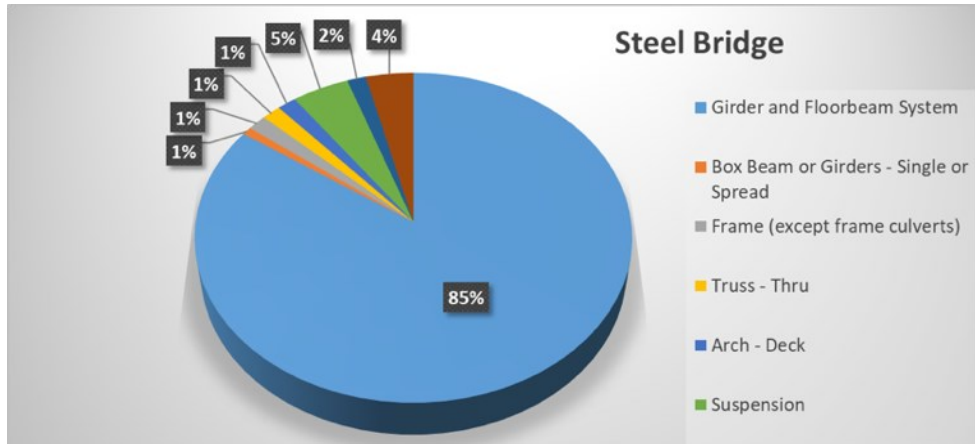
**Figure 4: Distribution of Structural Types in Simply Supported Steel Bridges**

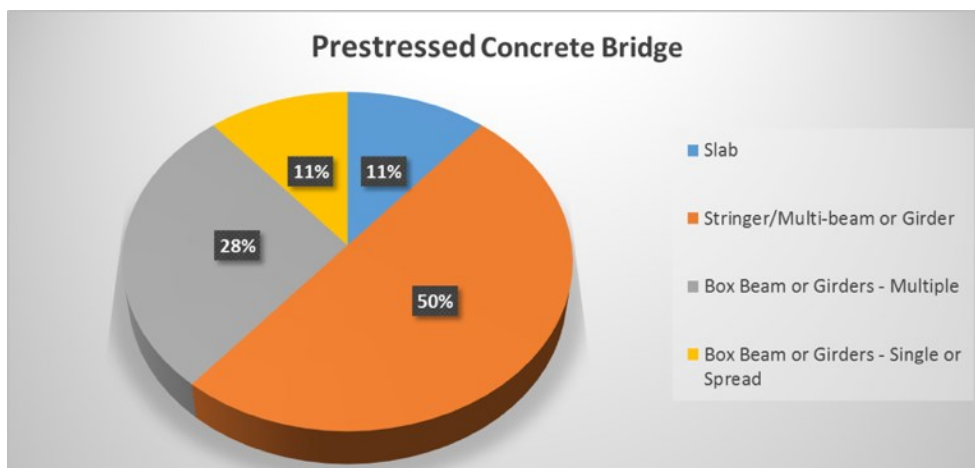
**Figure 6: Distribution of Structural Types in Simply Supported Prestressed Concrete Bridge**

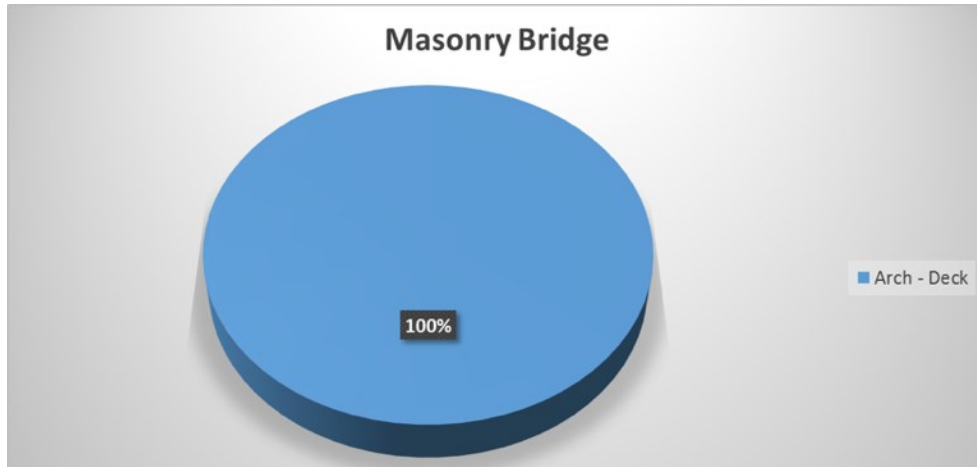
**Figure 7: Distribution of Structural Types in Masonry Bridges**

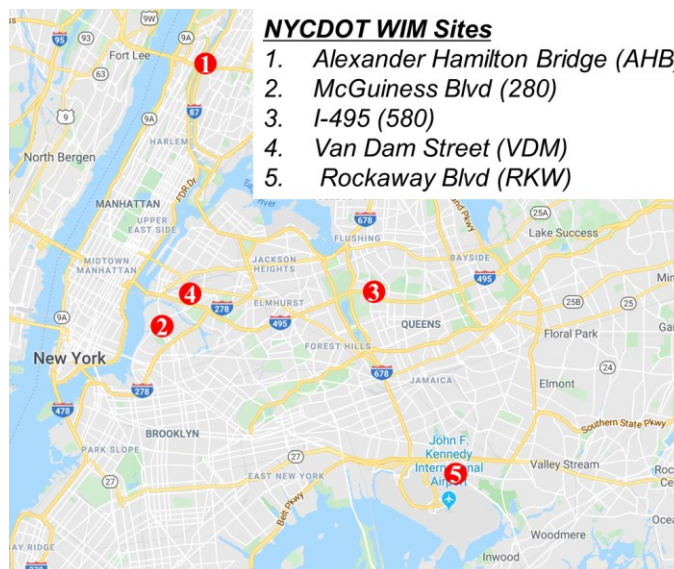
**Figure 8: Spatial Locations of the NYCDOT WIM Sites**

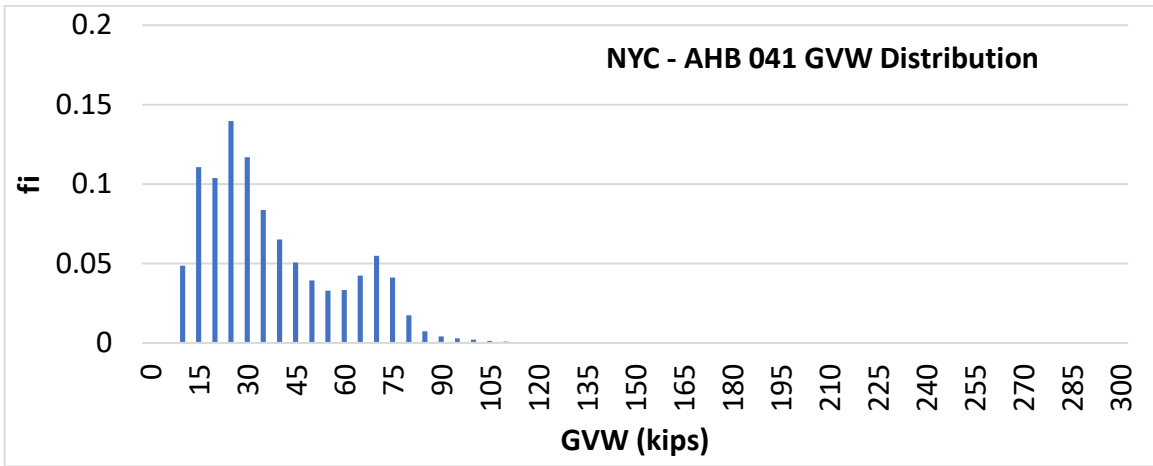
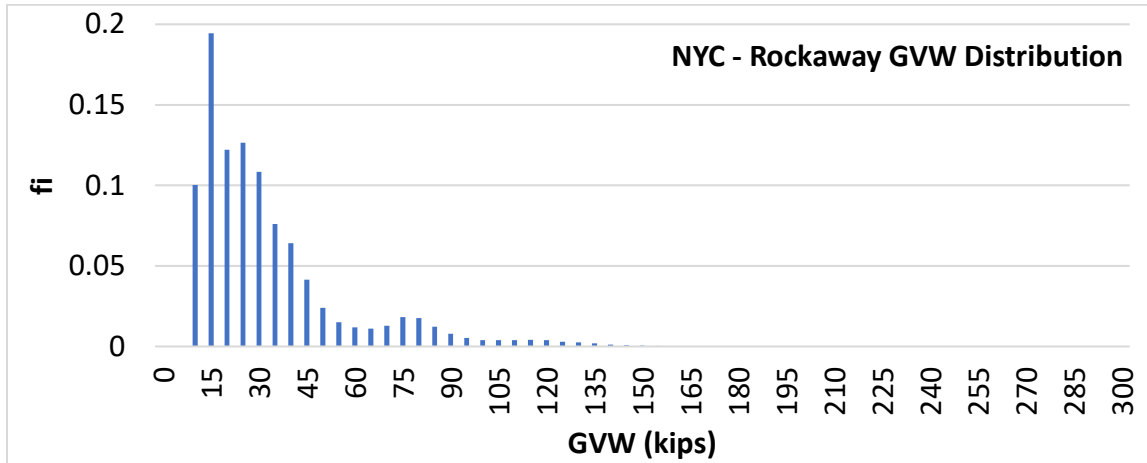
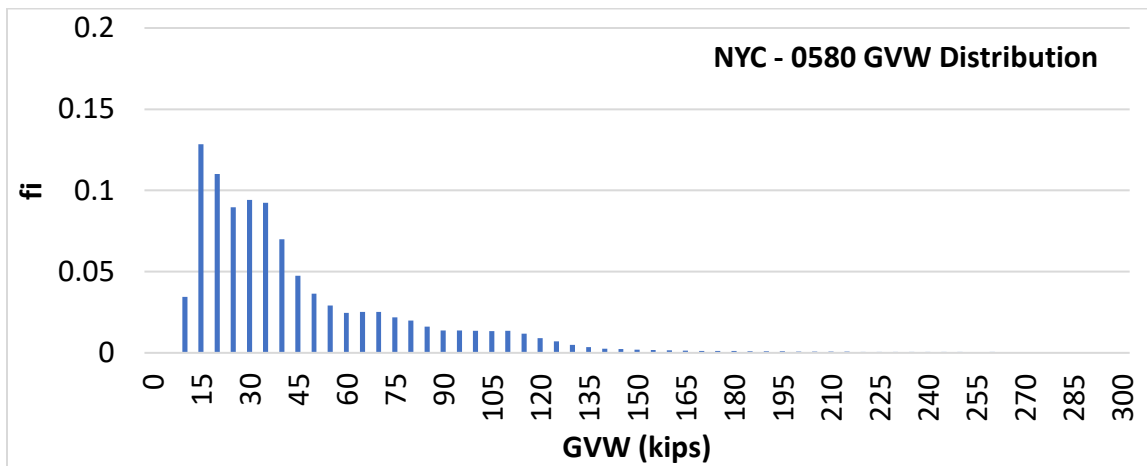
**Figure 9: Distribution of GVW from Selected WIM Sites**

For NYC, the team is currently collaborating with the NYCDOT to establish multiple WIM sites to help the City develop a WIM database to monitor the traffic patterns in NYC. The selection of sites for the installation of WIM systems is based on the traffic pattern, speed restrictions, and the distance from the abutment, but it also depends on the characteristics of the most predominant bridge types in NYC. The team has selected 5 WIM sites shown in Figure 8, and the results of data processing are shown in Table 1. The results show that Site 580 has the highest truck percentage, while Site AHB 041 has the most daily overweight trucks. Site Van Dam, 580, and 280 have a high overweight percentage. The GVW distribution for different sites is shown in Figure 9.

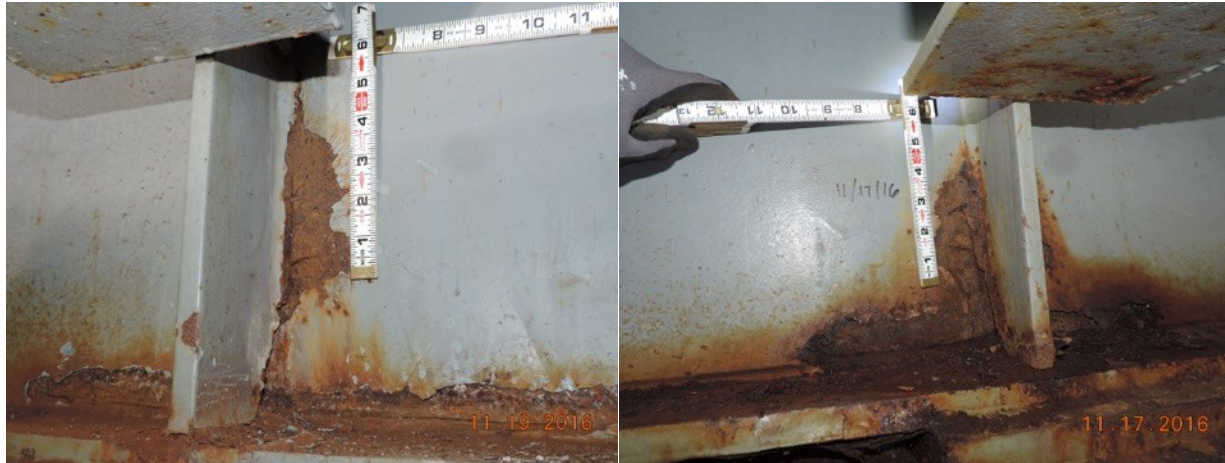
**Figure 10: Vertical and Horizontal Fatigue Cracks on the Left Side of the Web Stiffener**

- Vertical and horizontal fatigue cracks on the primary member with some corrosion on the secondary member (gusset plates) were observed for spans 4, and 5: Condition Rating 5 – 4

- Primary and secondary member condition for spans 4, and 5 remained unchanged: Condition State: 4 (Figure 10). “28, 29, 30, 31, 32, 33, 53, 54, 55, 56, 57, 58”

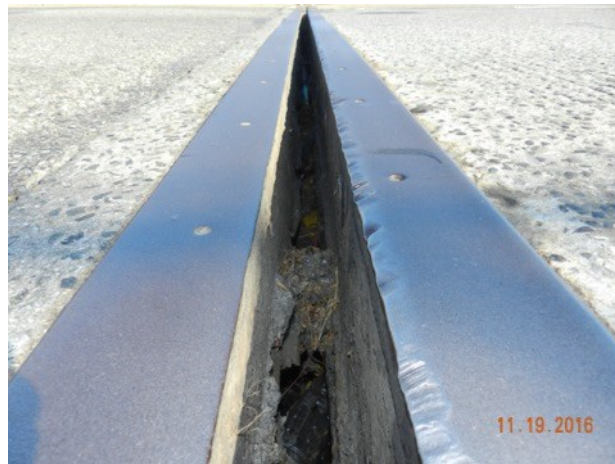
**Figure 11: Missing Compression Joint Seal**

- 2 out of 4 missing bolts below the floorbeam at Column #9 Girders G1 located on span 4: Condition State: 3. “38”
  - Missing compression Joint Seal at span 4, and 5: Condition State: 4 (Figure 11)

As a summary, corrosion and section losses are observed mainly at spans 4 and 5 of this structure. Missing compression joint seal could potentially open the path for water to leak thru the intermediate deck joint, therefore lead the steel to corrode. In addition, fatigue cracks are identified at spans 4 and 5. This could be potentially caused by overweight vehicles.

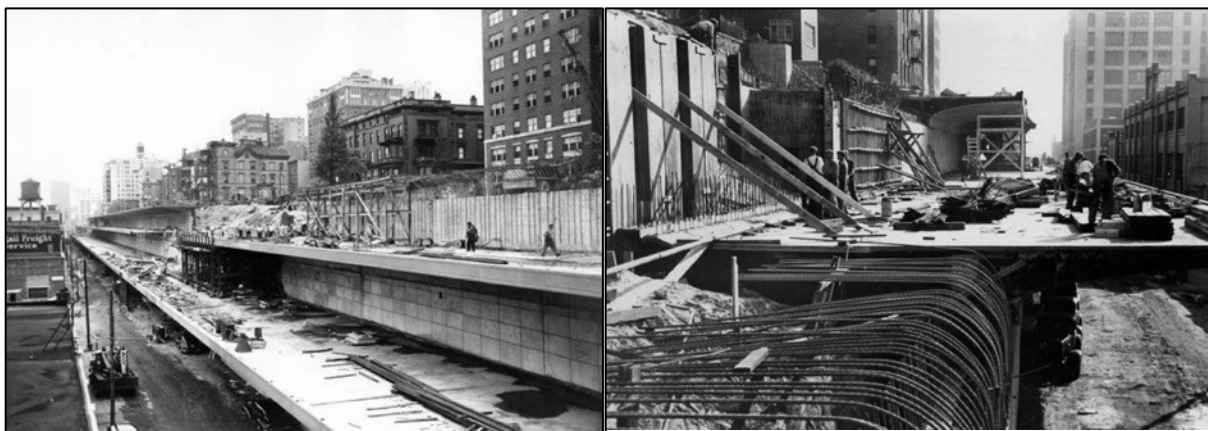
**Figure 12: Brooklyn-Queens Bridge Triple Cantilever Picture During Construction (Reference: New York City Parks Photo Archive)**

The Brooklyn-Queens Expressway (BQE) was built in 1944 by Robert Moses, connecting the Gowanus Parkway and Robert F. Kennedy Bridge in New York City (Figure 12). Since then, the BQE has been one of the most heavily traveled roadways in New York City and beyond, with average daily traffic (ADT) of 153,000 vehicles. In addition, this corridor is the crucial freight route in New York City, with a peak volume of up to 1,100 trucks per hour (500-600 trucks per direction) during weekday mornings and average daily truck traffic (ADTT) of 25,000 trucks. The triple cantilever section, which splits the BQE on three cantilevers carrying two levels of traffic and Promenade, has been disproportionately impacted by overweight trucks and environmental conditions. Accordingly, the structure has been suffering from extensive deterioration, as shown in Figure 13.

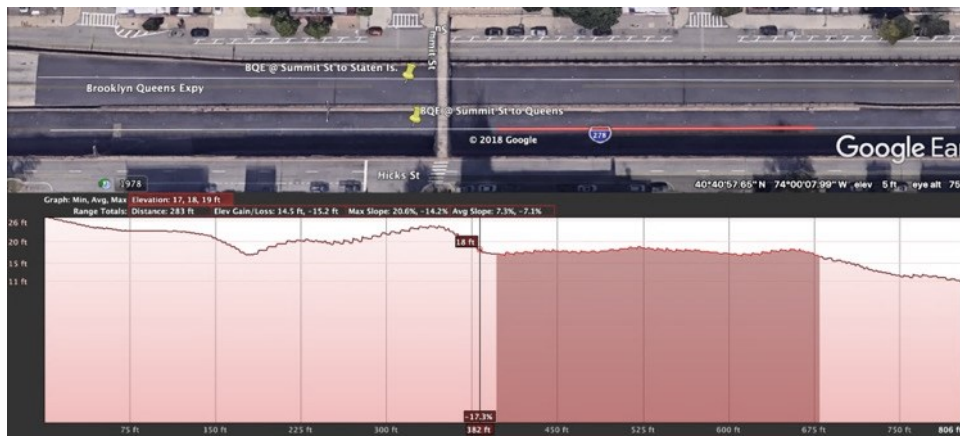
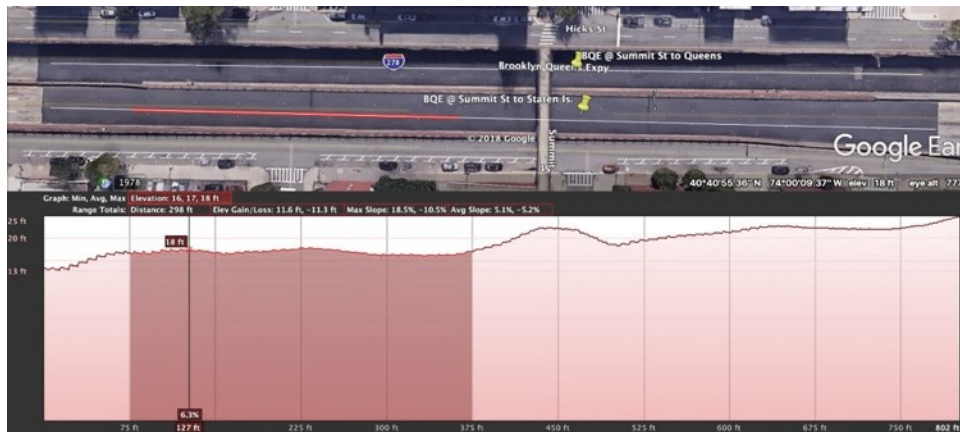
**Figure 15: Pavement Profile at Site 1; (a) Queens Bound (Staten Island to Queens), and (b) Staten Island Bound (Queens to Staten Island) (Reference: Google Earth)**

The Google Earth provides the pavement profiles along the road – inclination and roughness. Although the pavement data is low resolution and may not be accurate, it would give good information to compare the relative pavement condition between segments. The segments between Summit Street and Carroll Street (the north portion of the pedestrian bridge over BQE) were selected based on the research. Figure 15 shows the pavement profile on BQE from Google Earth. Local elevation peaks and relatively high roughness were observed for the Queens Bound (Figure 14(a)). The average slope was 7.3%. This results in the elevation difference being less than 1 ft over 300 ft. Similar roughness and elevation changes were observed for the Staten Island Bound (Figure 14(b)). The average slope was 5.1% (2.2%p less than QB). In both directions, cracks were observed on the pavement.

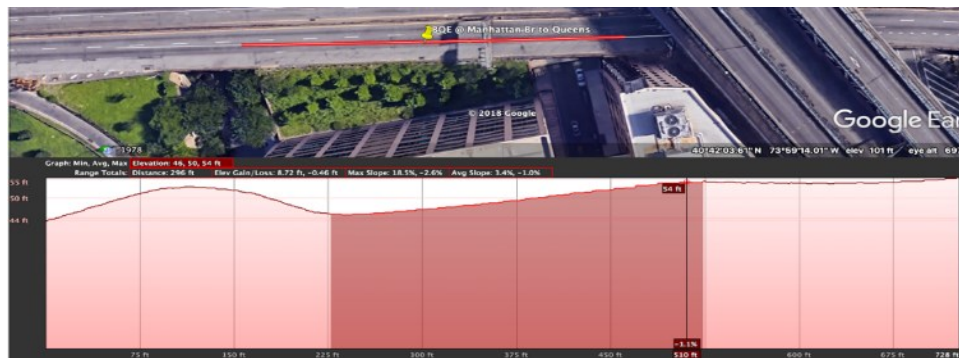
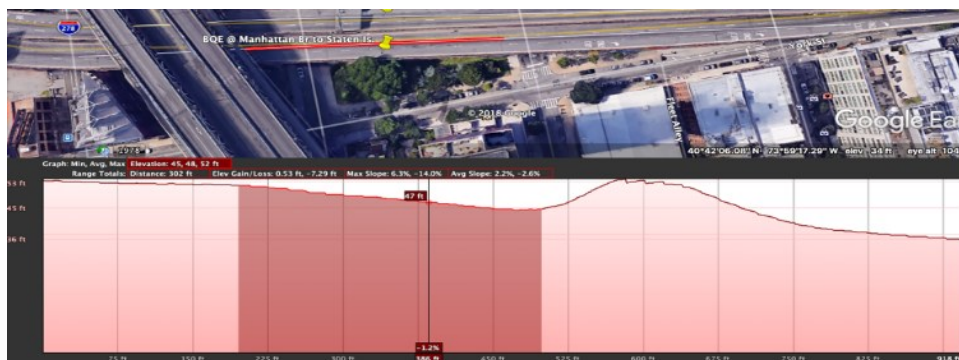
**Figure 22: Pavement Profile at Site 2; (a) Queens Bound (Staten Island to Queens), and (b) Staten Island Bound (Queens to Staten Island) (Reference: Google Earth)**

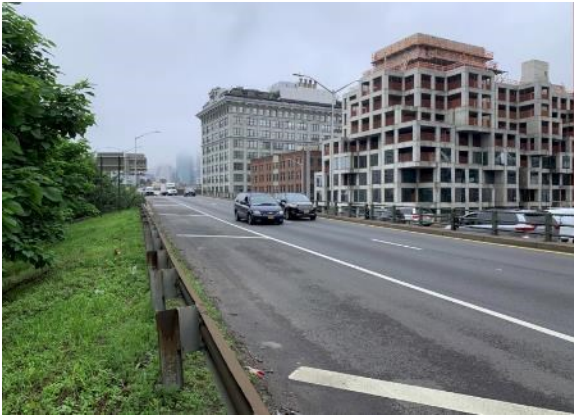
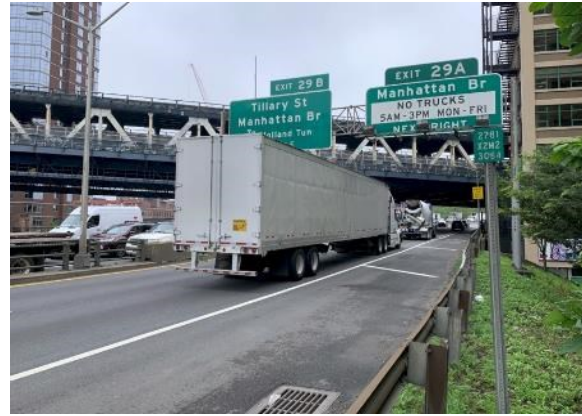
**Figure 23. Field Condition at Site 2; (a) Acceptable Roughness and (b) Narrow Lane**

Figure 23 shows the field condition of BQE Site 2. Figure 23(a) shows that two lanes (+ shoulder) were active to Queens and three lanes to Staten Island. The roadway slope was acceptable, and some rutting was observed. Figure 23(b) shows that the lanes were wider than Site 1, but it was still narrow (less than 11 ft).

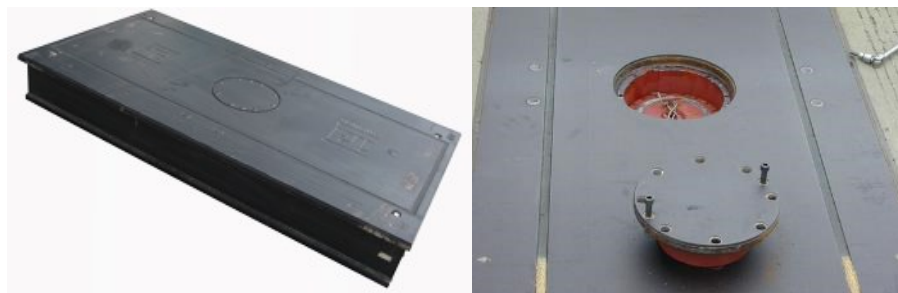
The single load cell sensor utilizes a dynamic rated load cell to measure the vehicle weight that is embedded in an enclosure covered by a rigid steel plate. The wheel force directly presses the single load cell that is proportional to the vehicle weight. The load cell does not have any inherent error due to temperature and pavement type because the load cell is encased with solid material. Such encasement provides good accuracy, and the load cell provides the most accurate weight data compared to PVDF and Bending Plate. The tolerance of gross vehicle weight of the single load cell is within  $\pm 6\%$  of the actual vehicle weight. However, the load cell requires a huge cut of pavement, and therefore, it is the most expensive for installation and maintenance among all types of sensors. The estimated annum cost is reported to be \$5,982~\$8,300 with a 10% discount rate over 20 years (Mimbela et al., 2000; Bushman et al., 1998; Zhang, 2007).

**Figure 28: Load Cell and Installation Example**

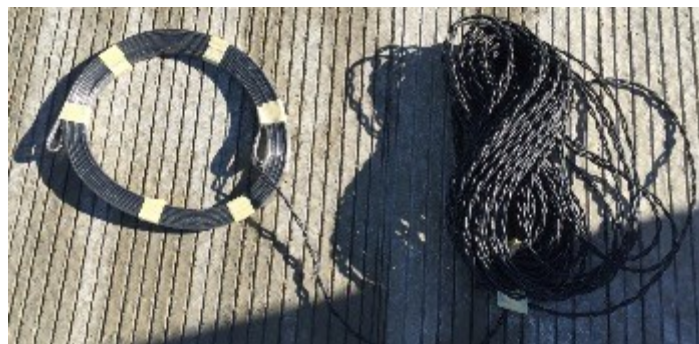
The preformed Sawcut Style Loop consists of a non-spliced and machine-twisted lead-in copper wire insulated with a cross-linked polypropylene jacket. The inductive loop is installed into a slot in the roadway for permanent application. When a vehicle moves over the loop, the resonate frequency will change as a magnetic field in the loop area changes. A closed-loop 6 ft x 6 ft loop with 100 ft of cable was used for this project, as shown in Figure 30.

**Figure 30: Pre-sawcut Loop**

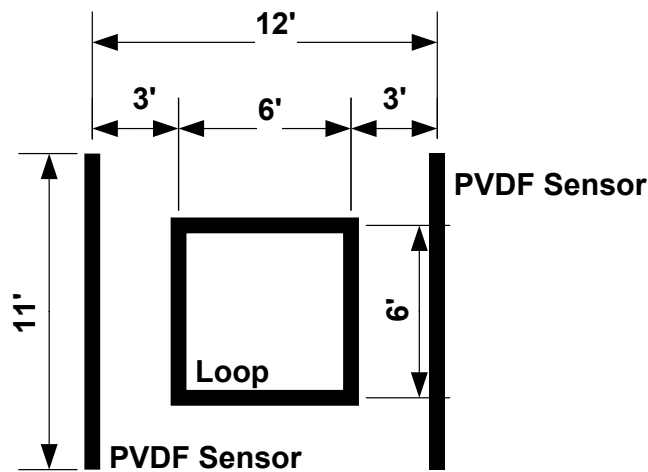
Two PVDF sensors and one loop were installed on each lane. Two PVDF sensors were distanced at 12 ft, and a loop with 6 ft. x 6 ft was installed in the center between two PVDF sensors. Each PVDF sensor will be 10 ft. or 11 ft., depending on the lane width. One PVDF sensor will measure the axle weight independently from another PVDF sensor, and the average of both PVDF sensors will be the axle weight for a given vehicle. The timestamp and known distance between two PVDF sensors will be used to determine the speed and axle spacing. Thus, the PVDF sensors will identify the axle weight and axle spacing, and the loop will identify the presence of each vehicle. Both sensors will be used to classify the vehicle per FHWA classification.

**Figure 31: Typical PVDF and Loop Layout**

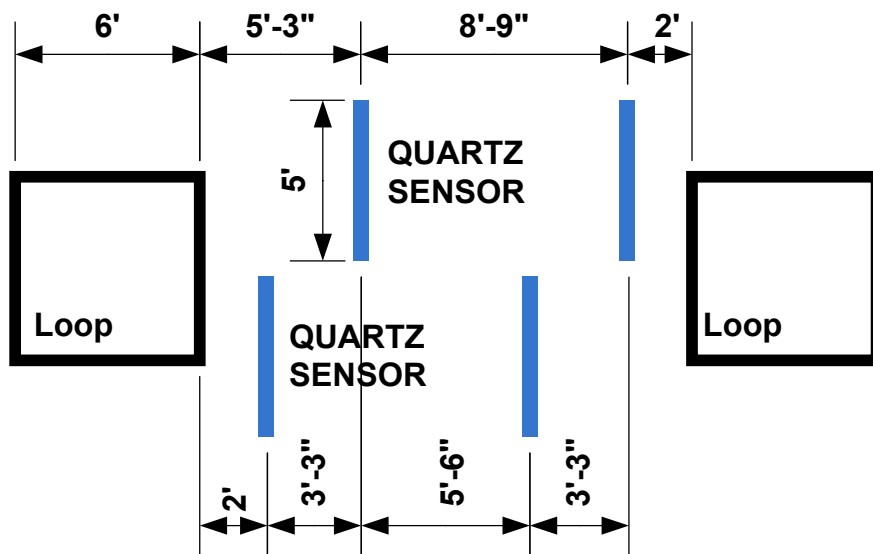
Four Quartz sensors and two loops were installed on the right lane of BQE QB. The team obtained the average speed at BQE, and Table 5 summarizes the average vehicle speed at peak hours. The team reviewed and discussed the speed data, site geometry, and pavement condition with the Kistler representative and determined the Quartz sensor layout as depicted in Figure 32. As can be seen in Figure 32, the sensor layout is different from the PVDF layout, and the Quartz sensors are zig-zagged distributed. This layout will help improve the axle weight, axle spacing, and speed accuracy when the vehicles are bumper-to-bumper because it has 4 independent readings at 4 distinct time stamps. Figure 33 shows the final layout of WIM sensors at BQE Site 2 near Pearl Street.

**Figure 32: Typical Quartz and Loop Layout**

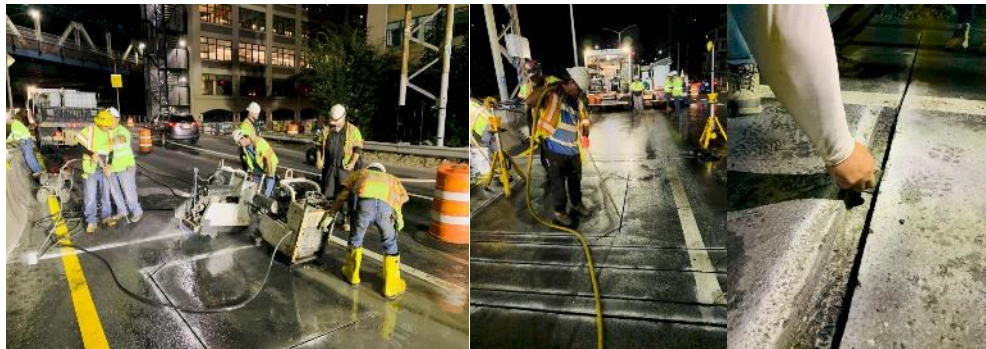
**Figure 35: WIM Sensor Instrumentation; (a) Layout Drawing, and (b) Sawcutting/Cleaning**

1) Determine the actual location depending on the review of on-site pavement condition. Draw the sensor locations using a rope and white spray per specification. The dimensions shall meet the specification requirement within tolerance. The sensors shall be perpendicular to the traffic flow and the sensor shall be located in the center of each lane. Drawing for cables may be combined, but drawings for sensors shall not be overlapped. Minimize or eliminate any drawing angle less than a right angle, which may damage the cable during operation.

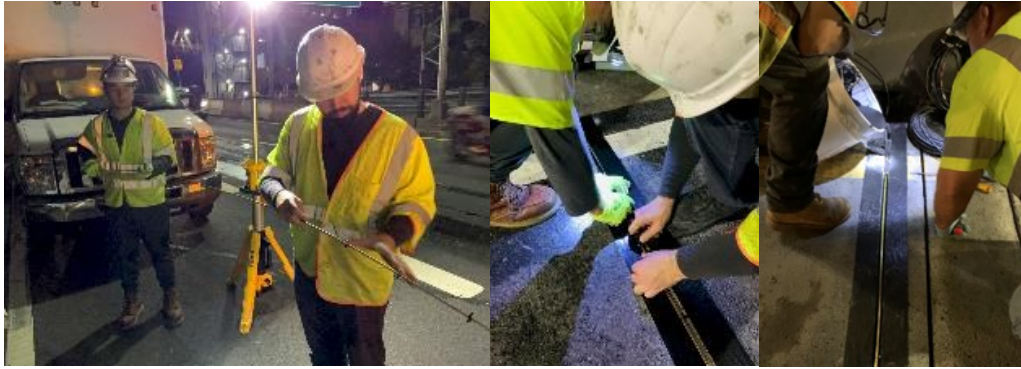
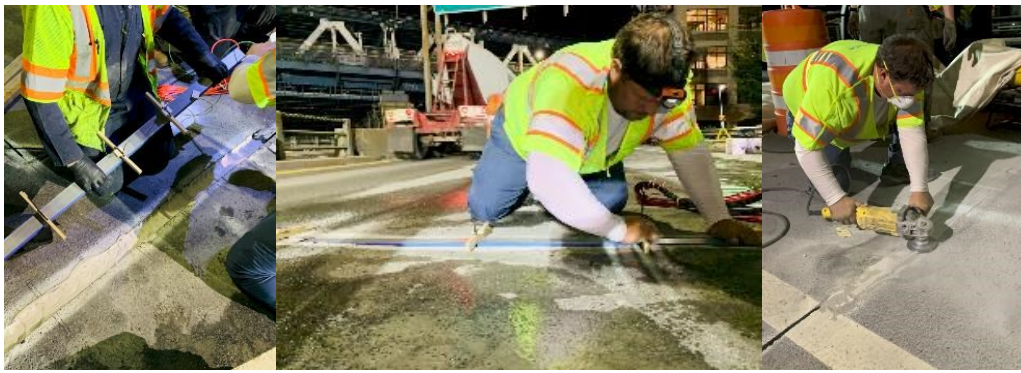
**Figure 36: WIM Sensor Instrumentation Procedure; (a) PVDF Sensor and (b) Quartz Sensor**

The WIM installation was performed for 3 consecutive nights between September 27, 2019, and September 30, 2019, from 10-11 pm to 5-6 am of the next day. The contractor cut, cleaned, and dried the slots for the WIM installation. Figure 34 shows the dimension of each slot for PVDF, Quartz, and Loop. In the meantime, the team prepared and cleaned the sensors and installed the sensors in the slots when the slots were dried entirely. Then the contractor poured the epoxy and finished the installation. Steps are summarized below, and Figure 36 summarizes the field pictures for each step.

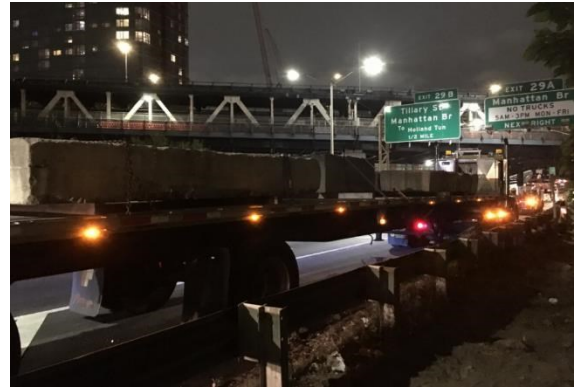
**Figure 42: Calibration Truck**

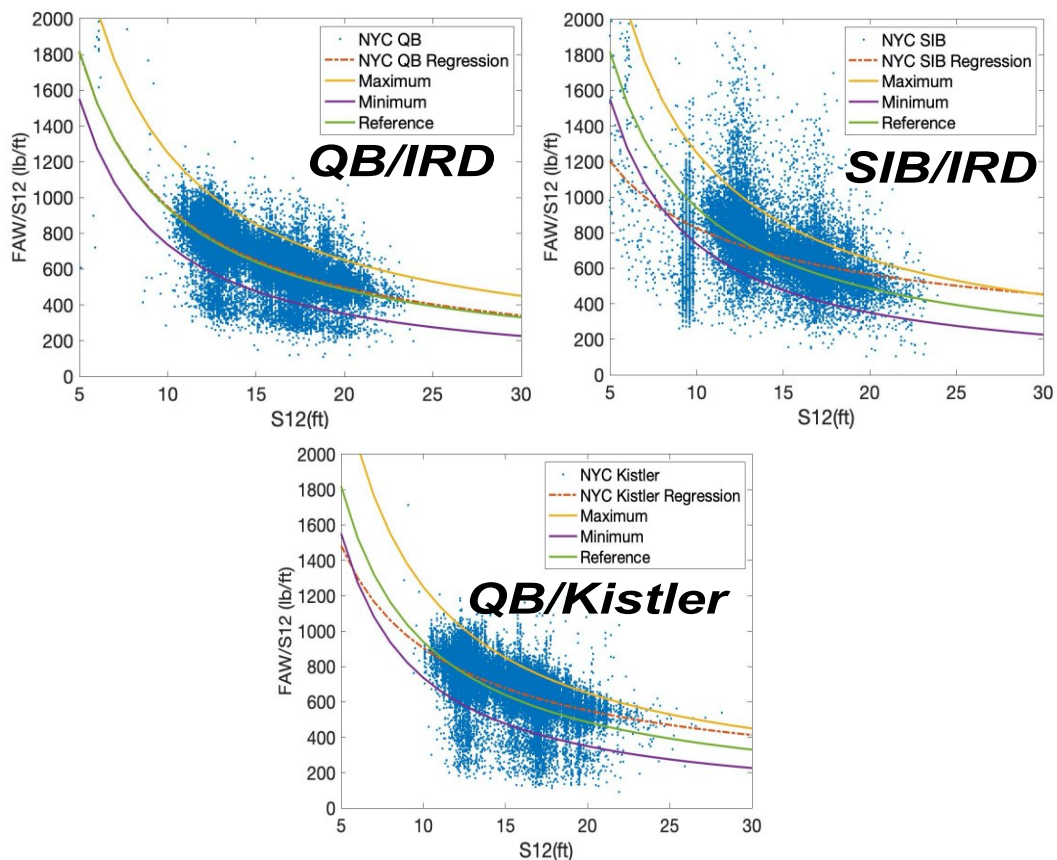
Figure 44 shows the Southgate regression curves for BQE WIM sites – IRD denotes the data collected by the IRD system and PVDF sensors, and Kistler denotes the data collected by the Kistler system and Quartz sensors. The Purple solid curve is the lower boundary, and the solid orange curve is the upper boundary, indicating the maximum steering axle weight to the spacing ratio by manufacturers' specifications. The solid green curve is the reference line that falls between lower and upper boundaries. The red dash curve is the regression curve of each site and year, and blue dots are each data point of Class 9 truck. the lower cut-off for blue dots is occurred by one of the NCHRP 12-83 filter (minimum axle weight = 2 kips). Some results over 2000 in y-axis (FAW/S12) are also cut-off for better visualization. The results also indicate that the dispersion is reasonable, and the data quality is confirmed.

**Figure 44: Southgate Regression Curve for BQE Site**

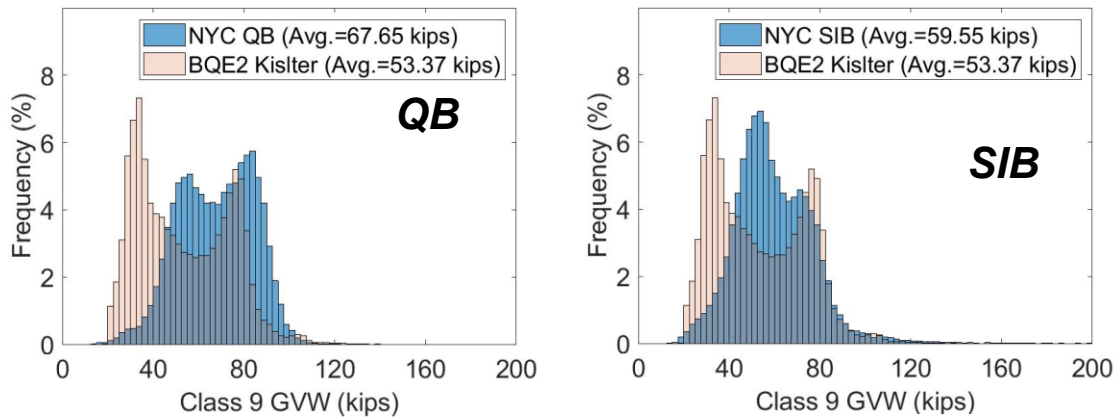
Figure 45 summarizes the distribution of GVW of Class 9 trucks compared to QB/Kistler data which would provide the most accurate data. For QB and SIB, albeit the GVW is biased to heavier weight. Figure 46 summarizes the distribution of FAW of Class 9 trucks compared to QB/Kistler data.

**Figure 45. Comparison of the GVW of Class 9 Trucks**

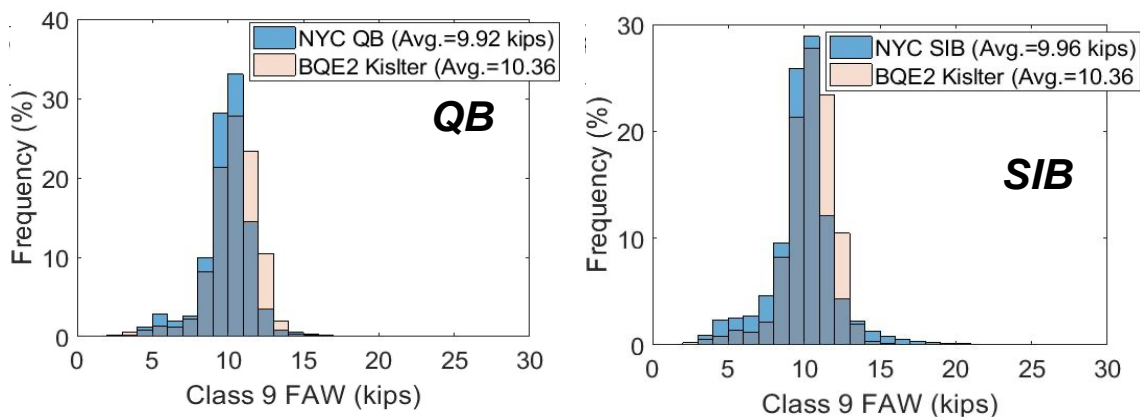
**Figure 46: Comparison of the Front Axle Weight of Class 9 Trucks**

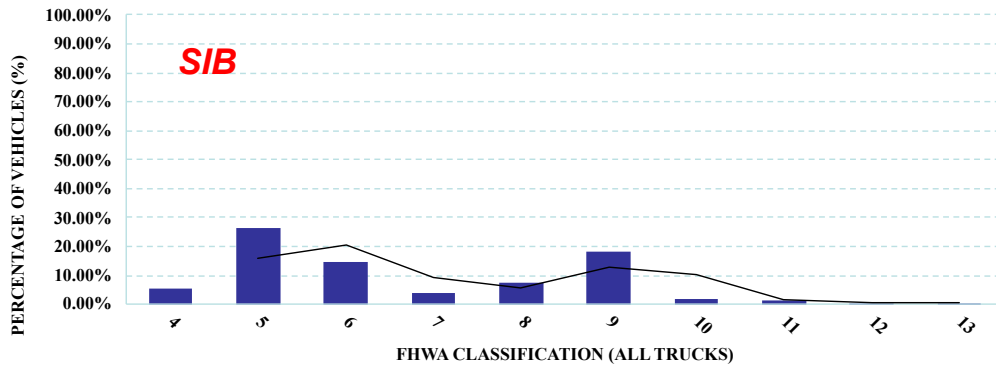
Figure 49: Distribution of Vehicle Classifications for IRD Data; (a) QB and (b) SIB

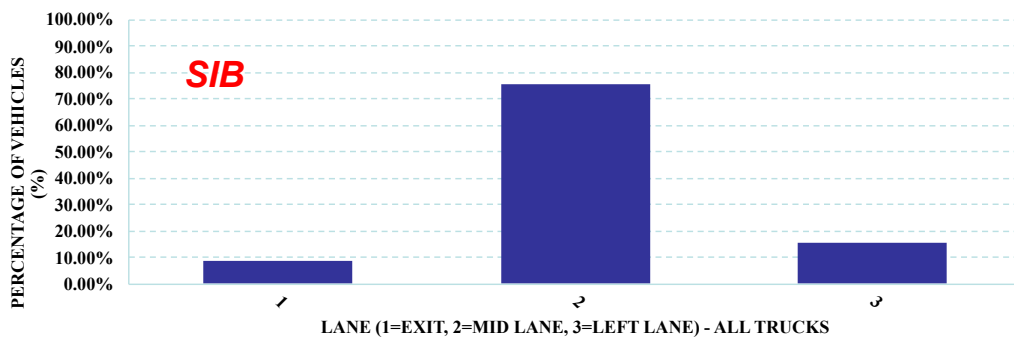
Figure 50: Distribution of Lanes of Vehicles for IRD Data; (a) QB and (b) SIB

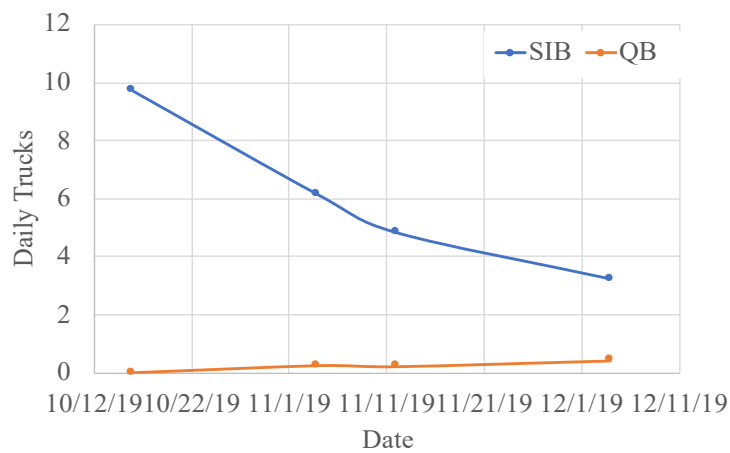
Figure 51: Number of Trucks above 150 Kips per Day
